## LAND CORNER RECORD

| Index: V-16 | Corner: E1/16 Corner between Sections 27 and 34 | State of Indiana - Hoosier National Forest | | |
| Section: 27 | Township: 7N | Range: 1E | P.M.: 2nd | County: Monroe |

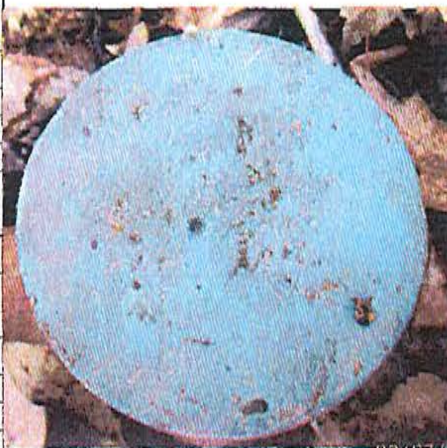
| Reference Objects: | Object or Tree Species: | Diameter: | Bearing: | Distance: |
|---|---|---|---|---|
| Monument Found or Set: | An iron pipe with a 3" brass cap found 0.3' above grade. | | | |

Monument is an iron pipe with a 3" brass cap found 0.3' above grade, a carsonite post is located 1.0' east of the monument, located on a western facing slope, +/- 40' west of the crest of a north-south running ridge, +/- 40' east of the edge of a steep slope heading to the west, +/- 500' north of St. Rd. 446, S60°W +/- 600' of a house, surrounded by mature forest, rock cairne at the base of the monument.

The record monument was found undisturbed and maintained by remarking three existing bearing trees and establishing one new bearing tree. Three existing bearing trees were recovered from an unknown source. Anderson did not have any notes on the existing bearing trees recovered.

Three bearing trees were marked with a bearing tree sign and mag nail.
